10027073, 11018097

EN Adding Zeolite fill tube shields

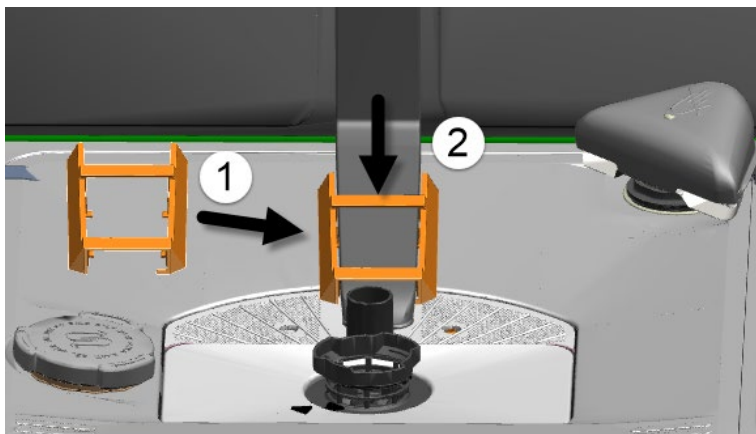
1. Open door and remove all racks. If needed for access, rotate or remove lower spray arm.
2. Align the fill tube shield over the fill tube with the wider open end toward the rear of the tub (1) and push it down to snap it into place onto the fill tube (2).

Perform fill tube shield preventative repair – install fill tube shield # 10027073 onto the fill tube whenever any unrelated repair is done on an affected unit.
